## Impact of the 20/4/2013 earthquake on Chongren's two schools in Mingshan

## Update for the donors

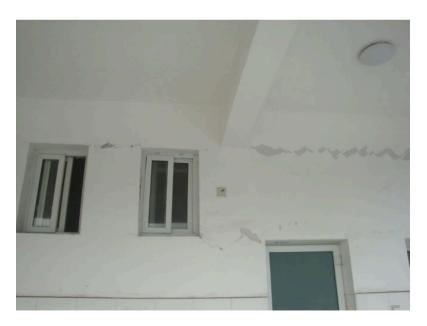
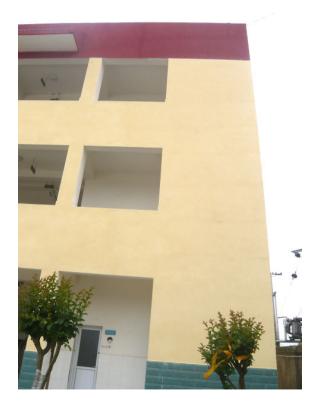
## Lianjiang Integrated Primary School

Lianjiang, being at around 40 km from the center of the earthquake, suffered only minor damage in the painting. The local Government renovated, nonetheless, the painting in the early days of May.

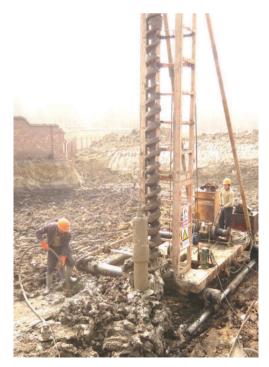
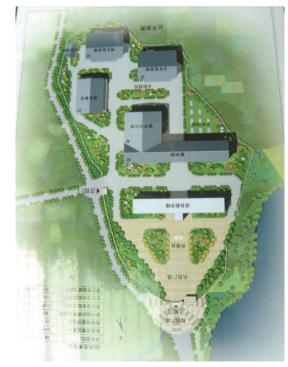
CFG pillars during the construction.

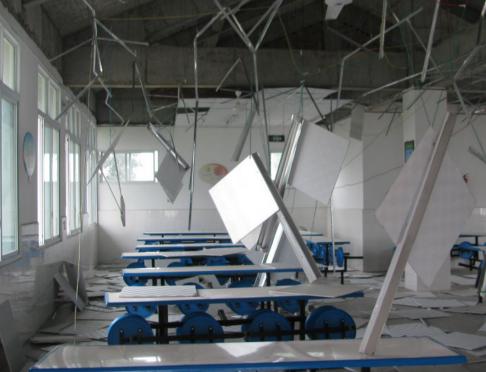
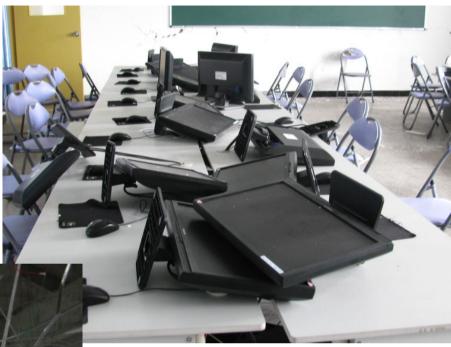
Although the earthquake turned movable things in the school upside down, there was little damage to the equipment, even not to the computers.
