## Impact of the 20/4/2013 earthquake on Chongren's two schools in Mingshan

## Update for the donors

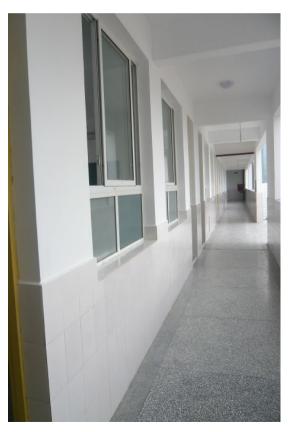
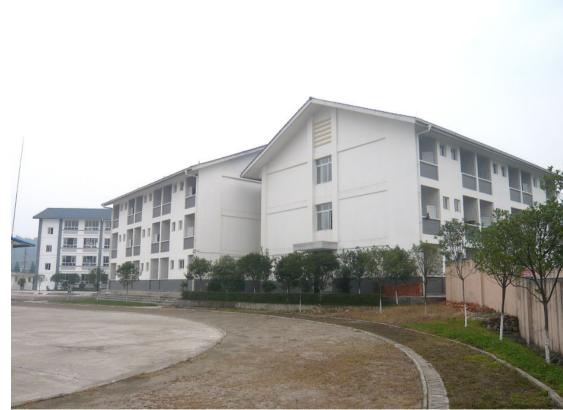
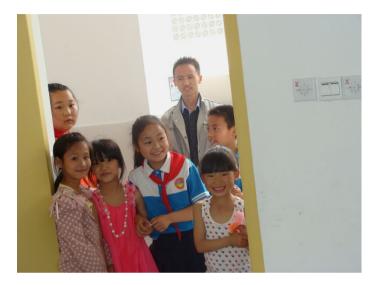
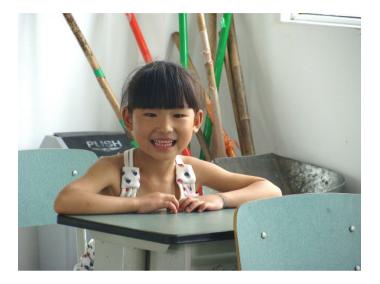
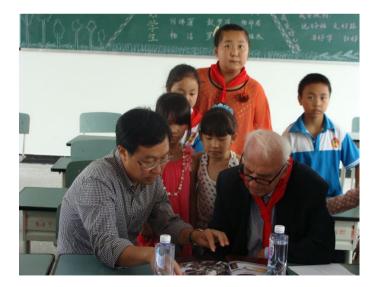
Although the earthquake turned movable things in the school upside down, there was little damage to the equipment, even not to the computers.

All repair works were financed by the local Government, thus no need for any support by Chongren.
